**LONG-TERM STORAGE TESTING OF PROPELLANT
TANKAGE**

Air Force Rocket Propulsion Laboratory
Edwards Air Force Base, California

AFRPL-TR-72-126

TECHNICAL REPORT AFRPL-TR-72-126

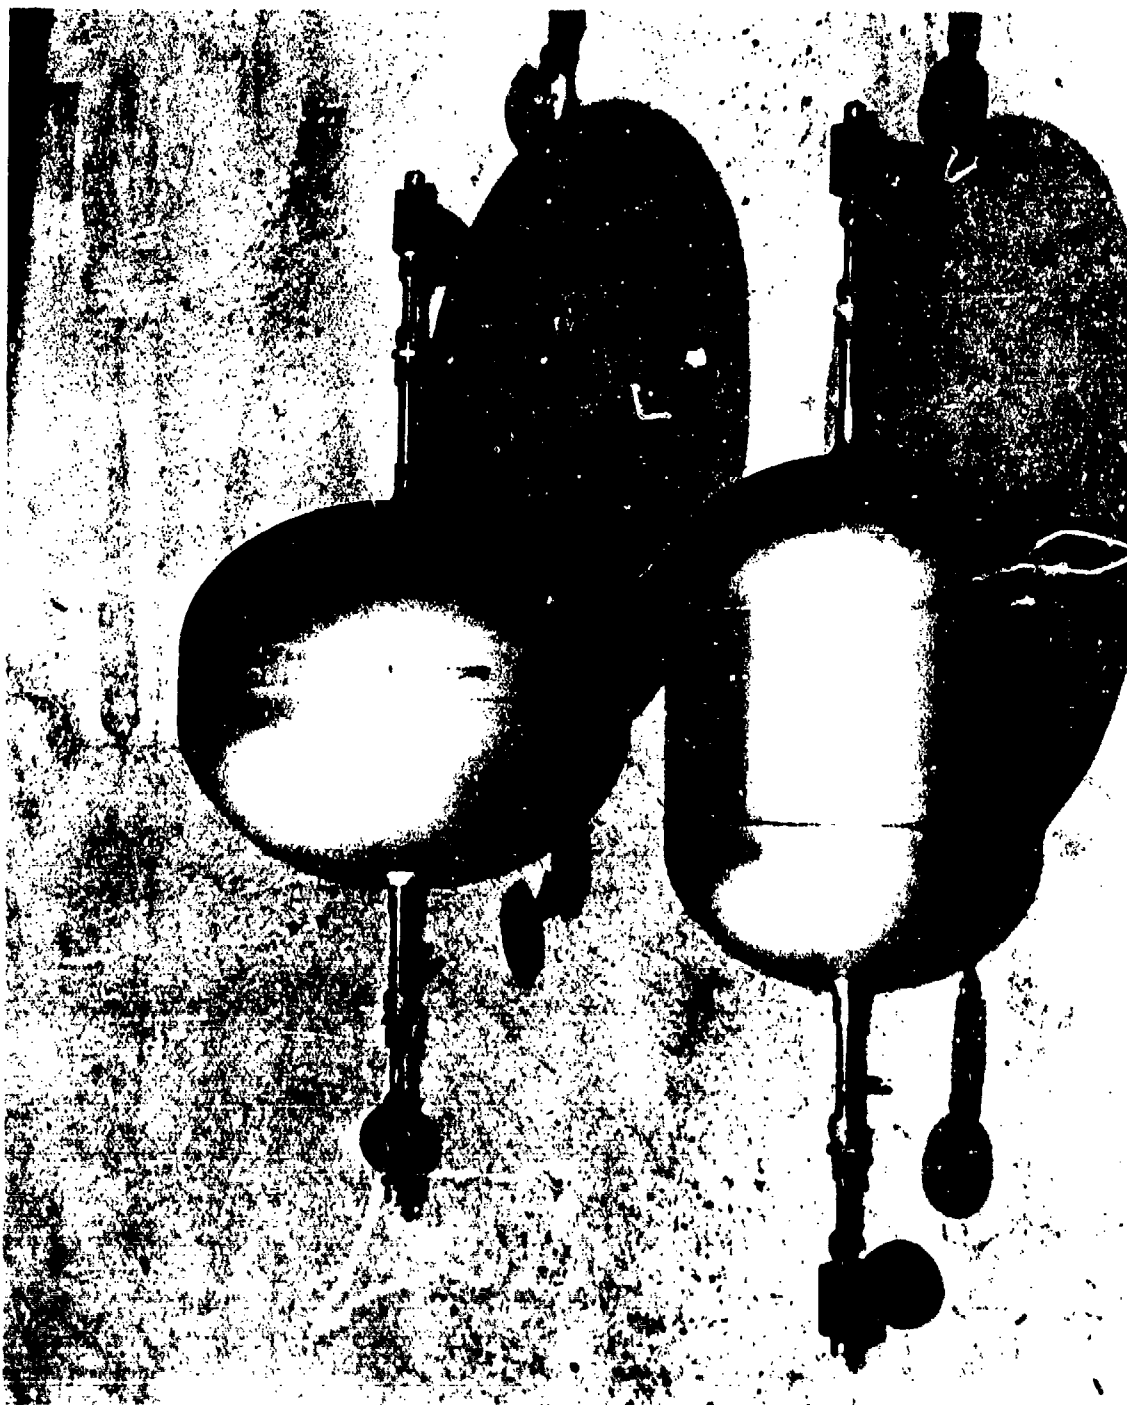
Figure 11. Solid State Bonded Tanks

These tanks were hardware delivered under an AFRPL program with Martin to demonstrate the explosive bonding technique in the fabrication of tankage. Two configurations (Figure 11) of tankage were fabricated from A286 stainless steel and one configuration was fabricated of 65A titanium. The A286 tankage is loaded with N_2O_4 (Specification MSC-PPD-2A) and ClF_5 , while the Ti-65A tankage is loaded with N_2O_4 (Specification MSC-PPD-2A).

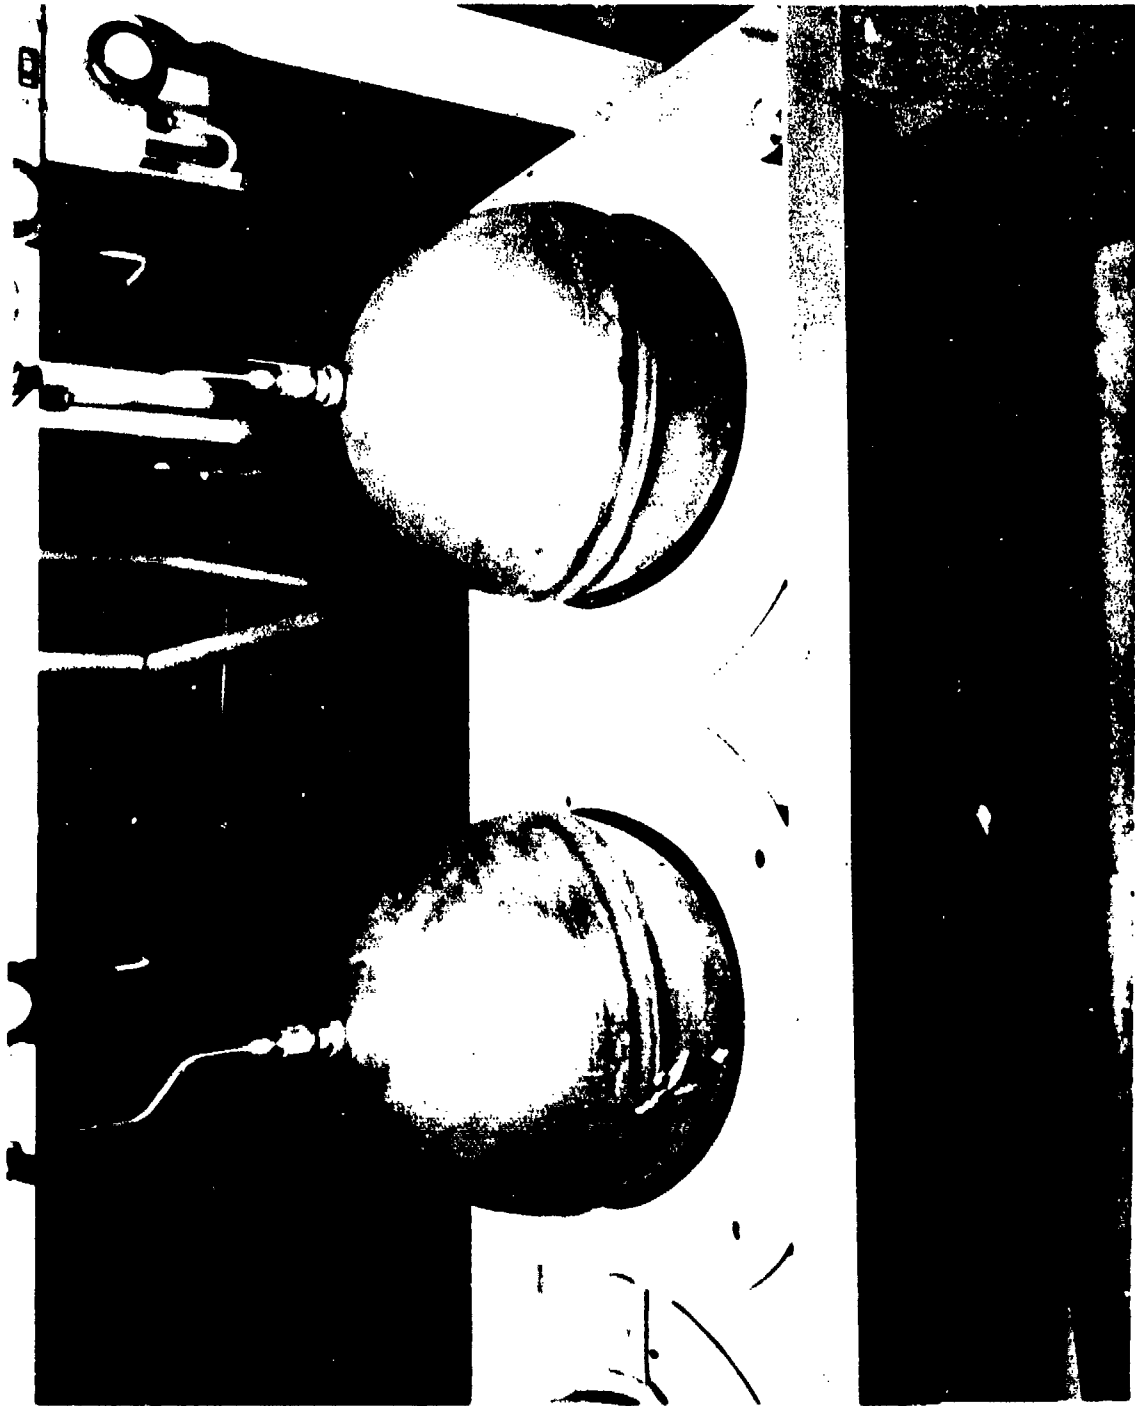
Figure 12. Twelve-Inch Arc Reversing Diaphragm Tank

There are two types of tankage in testing associated with its expulsion device (Figures 12 and 13). In all cases the tankage is AISI 301, cryogenically stretch-formed stainless steel. One group of six tanks 12 inches in diameter has a 304L stainless steel reversing diaphragm and is similar to that developed for LITVC tankage on the third stage of Minuteman III. These test articles are loaded with N_2O_4 (Specification MSC-PPD-2A), ClF_5 and N_2H_4 . Two 28-inch-diameter conospheroid tanks are also being tested with N_2O_4 (Specification MSC-PPD-2A). These tanks have an AISI 321 stainless steel expulsion diaphragm. All of this tankage was manufactured by Arde, Inc.

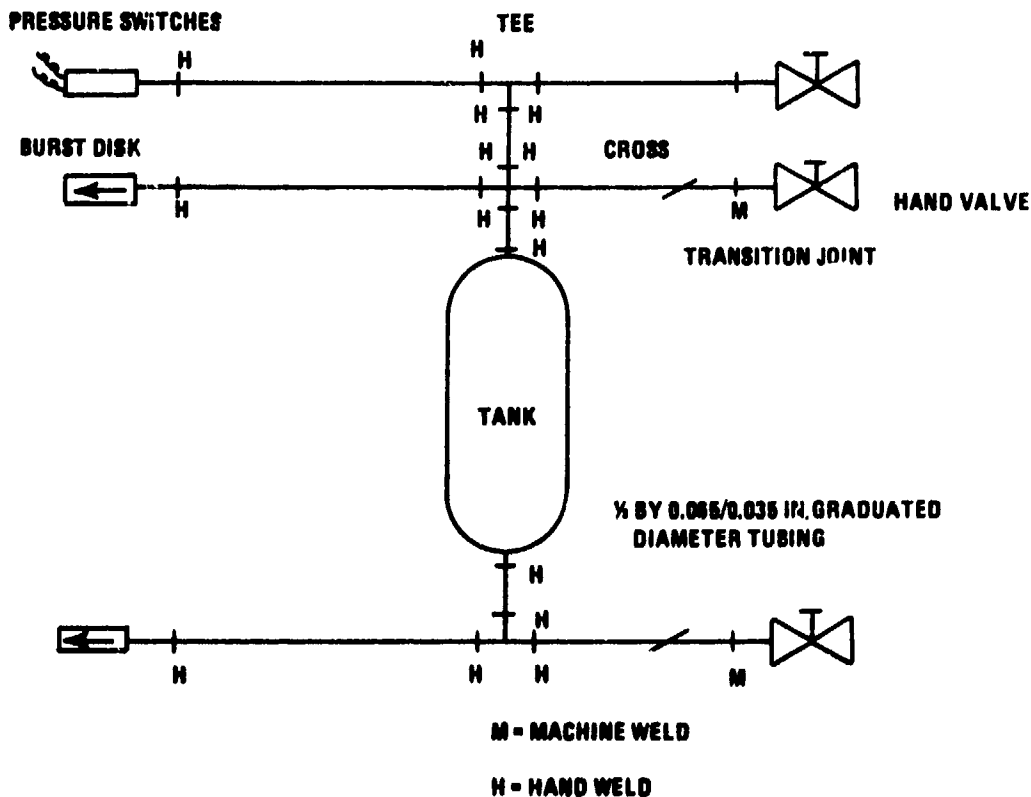
6061-T6 Al
347 SST/6061-T6 Al
347 SST
6061-T6 Al
6061-T6 Al
6061-T6 Al
347 SST
6061-T6 Al
6061-T6 Al
6061-T6 Al
6061-T6 Al

Figure 16. All-Welded Aluminum Systems for ClF_5 and N_2O_4 Application

The tanks here are similar to those described under Group II Storability Test Articles, but, associated with the tank on tubing located on the top and bottom, are fluid components normally found in liquid rocket systems. The tankage is either 2219-T81 aluminum or AM350 steel. Fluid components consist of a pressure switch, explosive valve and burst disk. Fittings are AFRPL mechanical fittings (MIL-F-27417) and TIG welded joints. Since tankage material and component materials are of both aluminum and steel, intermetal transitions are made using both mechanical fittings and solid state bonded transition joints. These systems are shown in Figures 15 through 19.

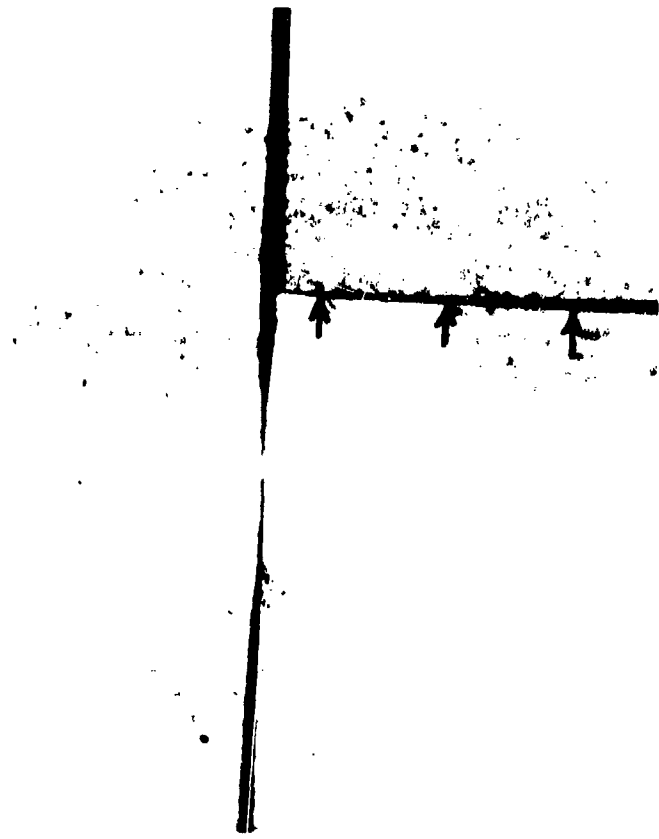
**Figure B-2. Same Location as Figure 1, With
Corrosion Products Removed and the Region
Sectioned. Arrows at Cross-Section
That was Examined**

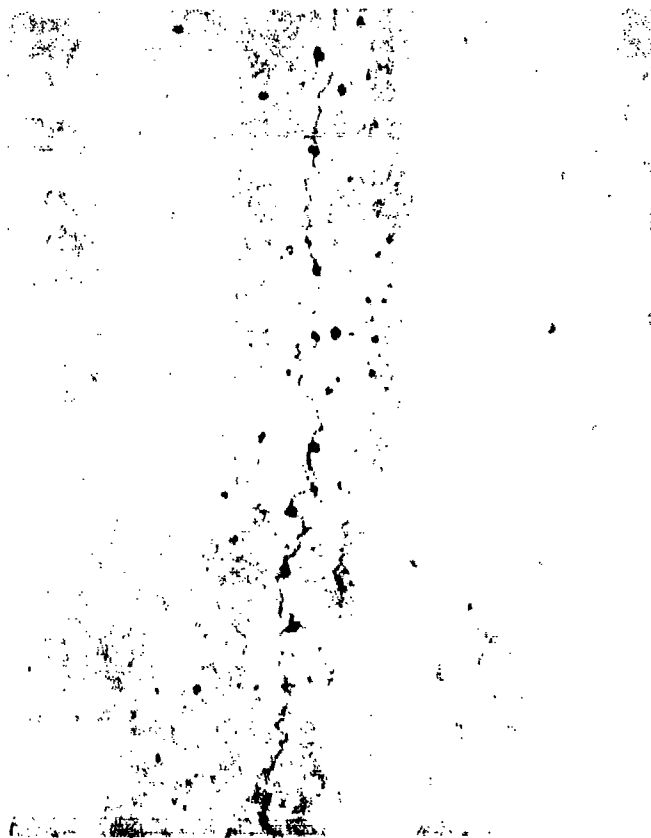
**Figure B-3. Crack in HAZ;
Parallel to Girth Weld**

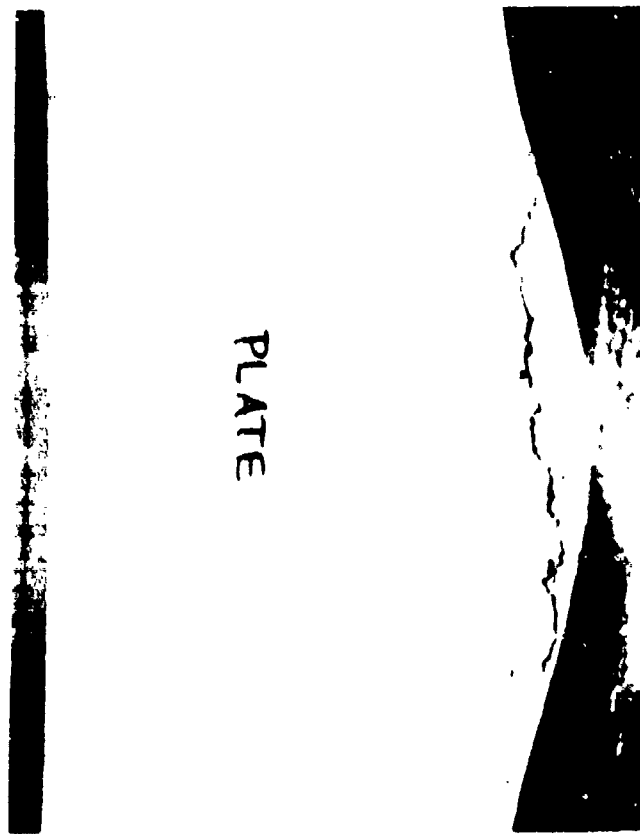
Figure C-4. First Cross-Section of Crack.
(Plane of Cross-Section is Parallel to
Long Axis of Pipe)
